TOWNSHIP OFFICIALS OF ILLINOIS RISK MANAGEMENT ASSOCIATION

# RISK REMINDER

## Crosby Swivel Hoist Rings

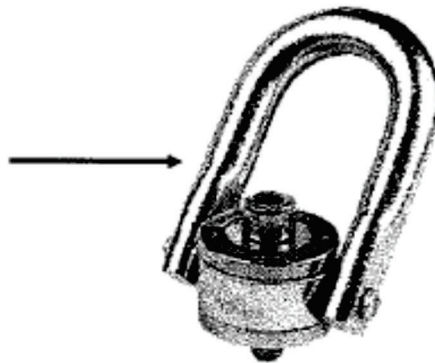
### Crosby Swivel Hoist Ring Bail

Crosby identified a recall on swivel hoist rings (bail location) that were found to be cracked. These are identified as HR-125 and HR-125M swivel hoist rings.

Recommended action by the manufacturer is to inspect all Crosby swivel hoist rings in stock, both in use and in inventory and replace as necessary. The picture below is an example of the recall on the Crosby ring that they have issued. The rings are identified with the Production Identification Code (PIC) Y5C marked on the bail, or Z7C marked on the bolt. Also below are the product details from Crosby.

All rigging equipment should be inspected for any signs of cracks or deformation of the bail and attachment pins prior to use.
