TOIRMA
PARTNERING WITH TOWNSHIPS
TOWNSHIP OFFICIALS OF ILLINOIS RISK MANAGEMENT ASSOCIATION
RISK REMINDER

# Crosby Swivel Hoist Rings

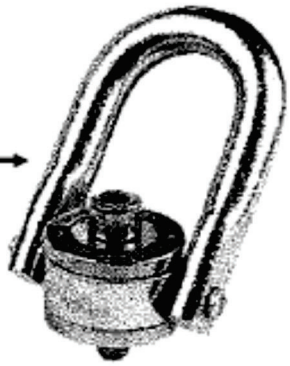
**Crosby Swivel Hoist Ring Bail**

Crosby identified a recall on swivel hoist rings (bail location) that were found to be cracked. These are identified as HR-125 and HR-125M swivel hoist rings.

Recommended action by the manufacturer is to inspect all Crosby swivel hoist rings in stock, both in use and in inventory and replace as necessary. The picture below is an example of the recall on the Crosby ring that they have issued. The rings are identified with the Production Identification Code (PIC) Y5C marked on the bail, or Z7C marked on the bolt. Also below are the product details from Crosby.

All rigging equipment should be inspected for any signs of cracks or deformation of the bail and attachment pins prior to use.
